नवीन किच्चा बैराज के उपयुक्त निर्माण स्थल के चयन हेतु किच्चा
नदी की रीवर मोर्फोलोजी अध्ययन

Study of Kichcha River Morphology for Identification of new site for Kichcha Barrage

NATIONAL INSTITUTE OF HYDROLOGY

December, 2024

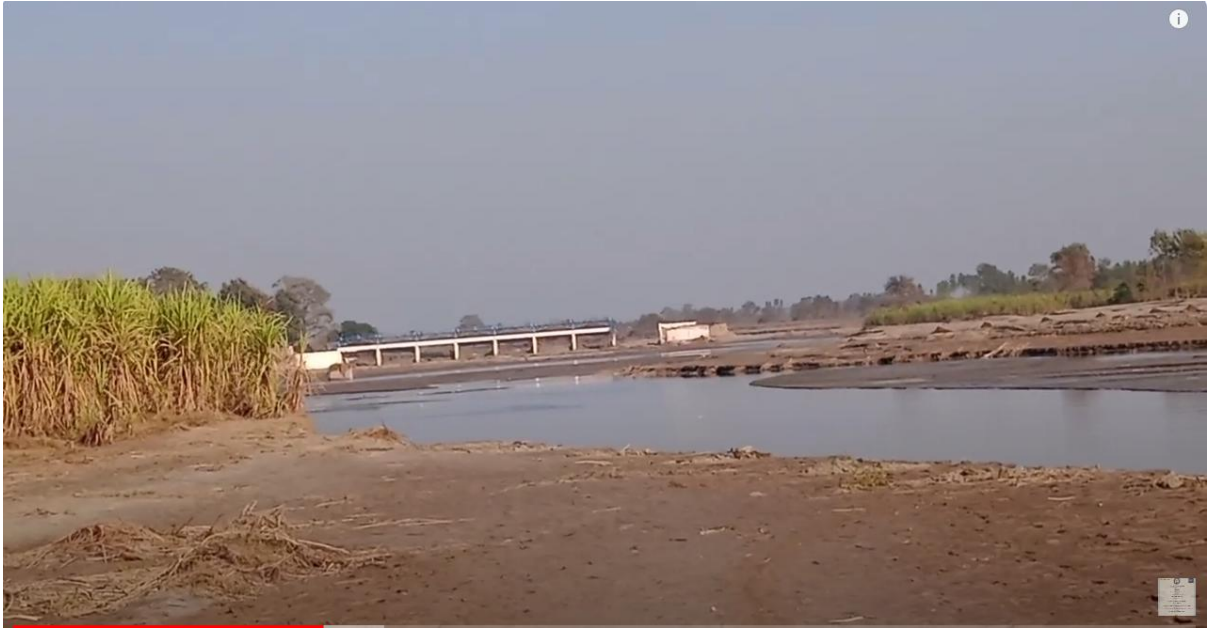
Figure 2.4: Kichha barrage after the devastating flood event of 19 October 2021.

Following the heavy rainfall on 18-19 October 2021 in the catchment and release of heavy discharge from Gaula barrage, the left marginal bund of Kichha barrage, head regulator and Kichha canal (partially) is washed away completely. The field photograph of the Kichha dam after the incident is shown in Figure 2.4 while the satellite image showing the extent of damage is illustrated in Figure 2.5.

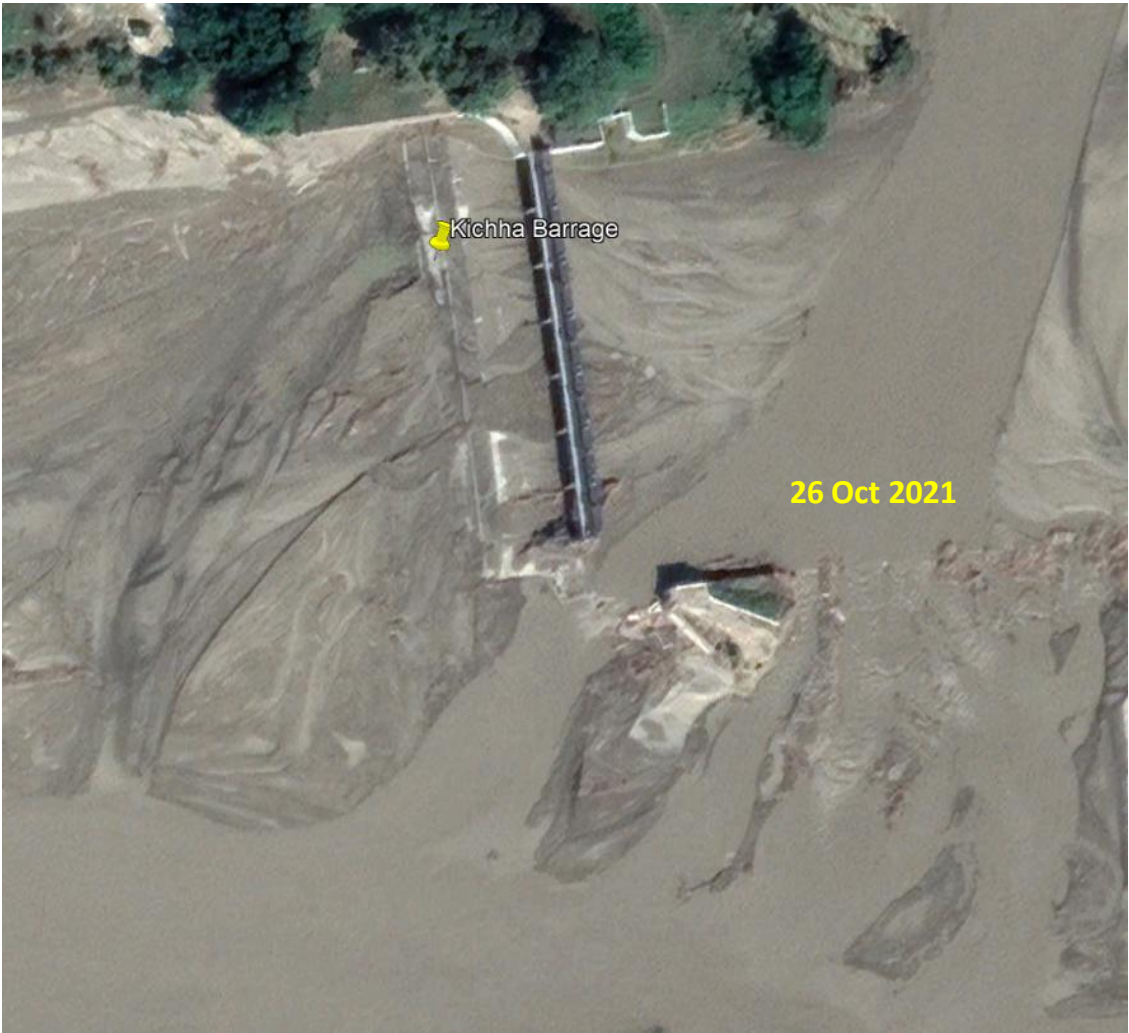
Figure 2.5: Satellite image showing damaged Kichha barrage as on 26 October 2021.

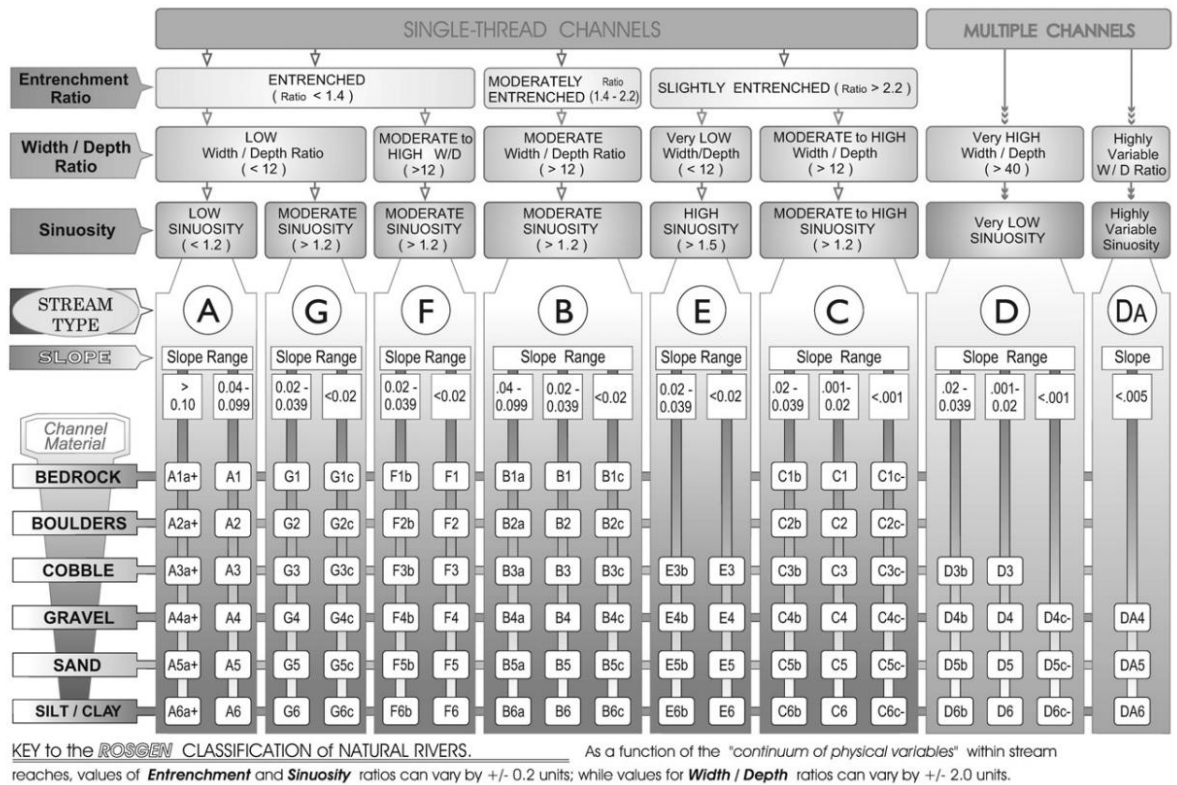
Figure 3.1: Stream type classification as proposed by Rosgen (1994, 1996b)

Recent approaches for river classification focus on watershed analysis related to land management and stream restoration, using a hierarchical approach that nests successive scales of physical and biological conditions and allows a more holistic understanding of basin processes. One of the most widely used hierarchical channel classification systems was developed by Rosgen (1985, 1994, 1996) for mountain basins. His approach involves four scales of analysis, ranging from broad-scale delineation of landform and valley type to small-scale measurements of physical processes (e.g., bed load transport, bank erosion) and biological inventories (vegetation, aquatic organisms). In practice, the classification is focused on delineating reach-scale morphologies and recognizes eight major stream types based on entrenchment (ratio of floodplain width to channel width), width-to-depth ratio, and sinuosity (Figure 12). A sinuosity range straight 1.1, sinuous 1.1–1.5, and meandering >1.5 (Leopold et al., 1964). A primary goal of the Rosgen (1994, 1996) method is “natural channel design” for use in stream restoration. The lower the entrenchment ratio, the more vertical containment of flood flows exists. Higher entrenchment ratios depict more floodplain development.

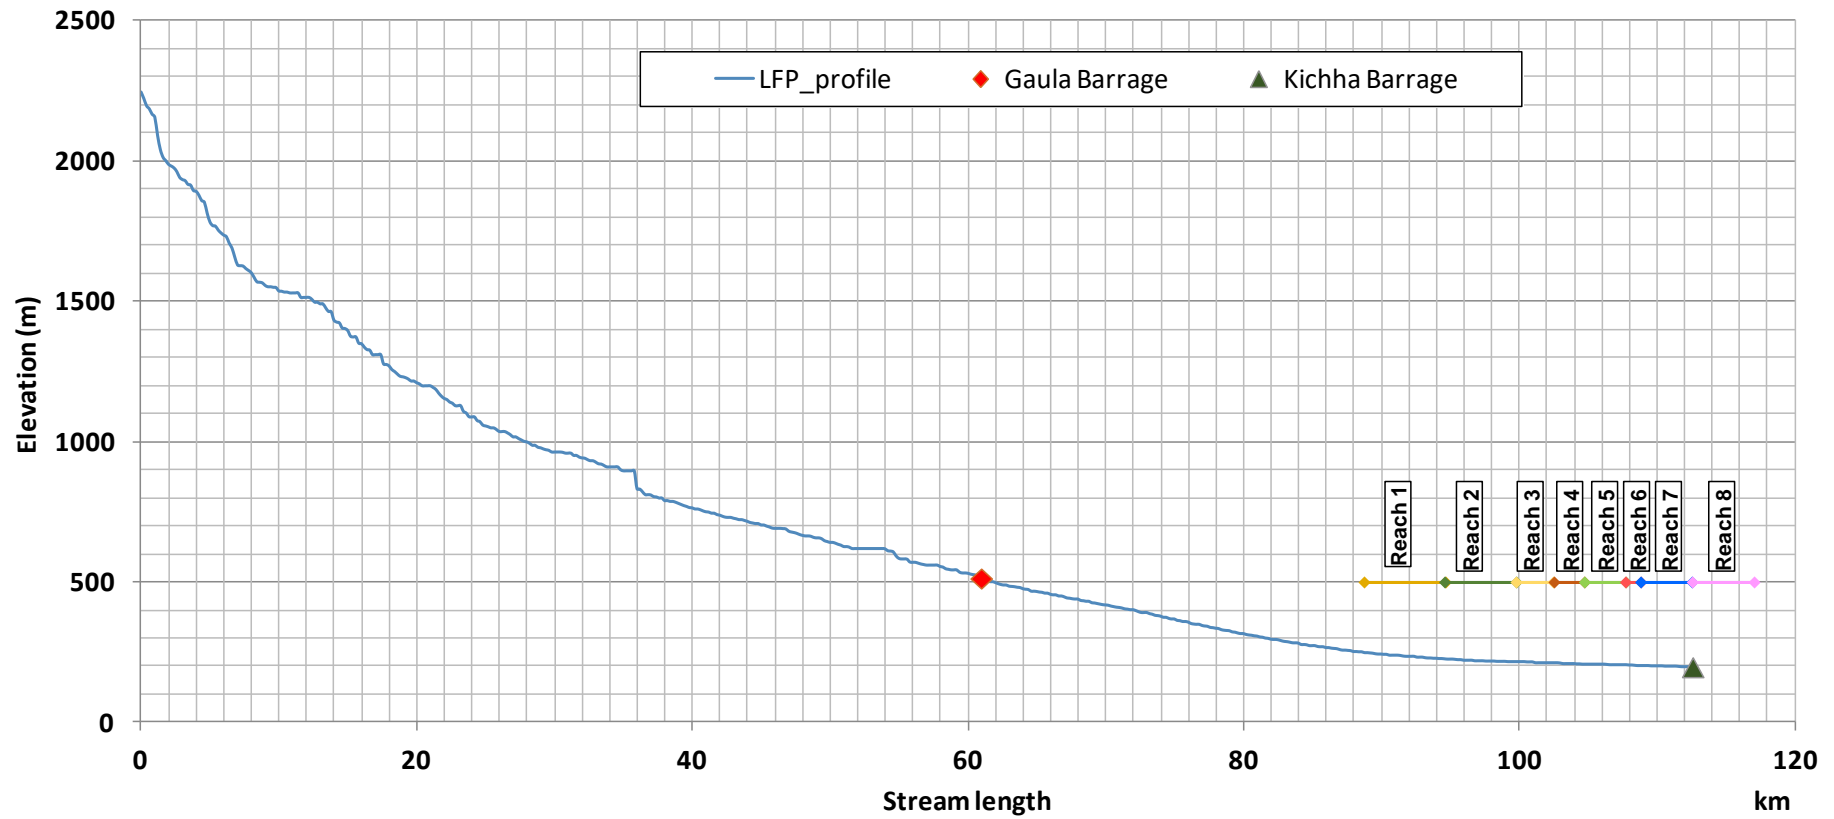
Longitudinal profile of Kichha river

Figure 4.1: Longitudinal profile of river.

The longest flow path is derived from the terrain analysis and the elevation of the points (at the regular interval of 200 m) along the stream is extracted. The longitudinal profile of the stream is then plotted, as shown in Figure 4.1, using these point elevations. The figure shows the location of Guala and existing Kichha barrage. The morphological characteristics of the river in the stretch of about 30 km (25 km upstream of Kichha barrage and 5 km downstream of Kichha barrage) have been evaluated. As the river slope and planform are highly variable in the stretch, this stretch is further divided into 8 reaches for detailed analysis. The location and extent of each reach is also shown in the figure.

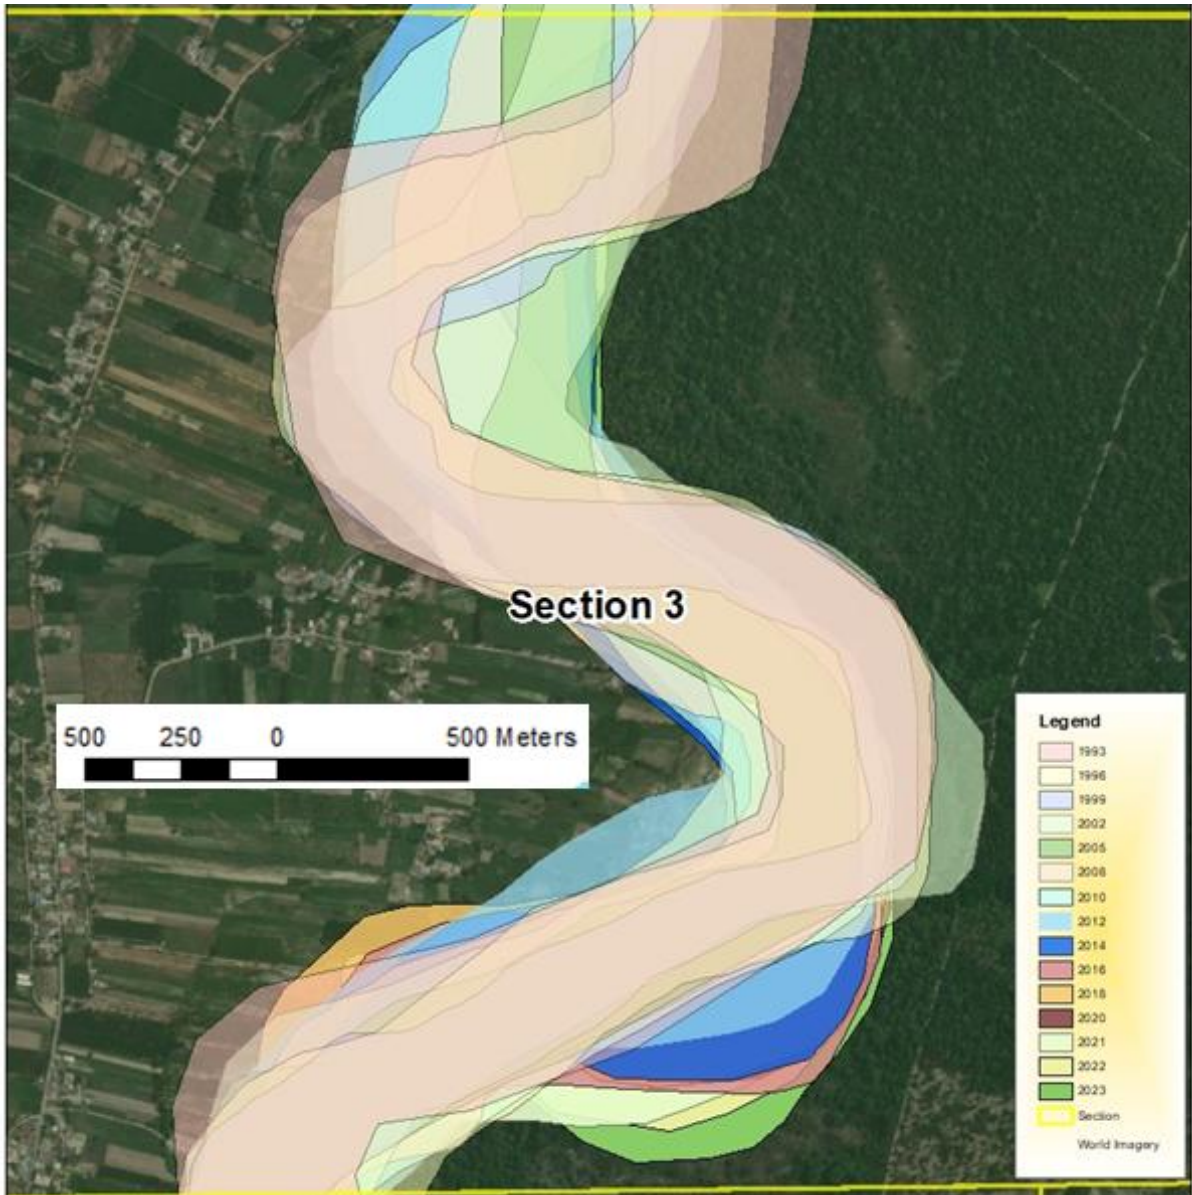
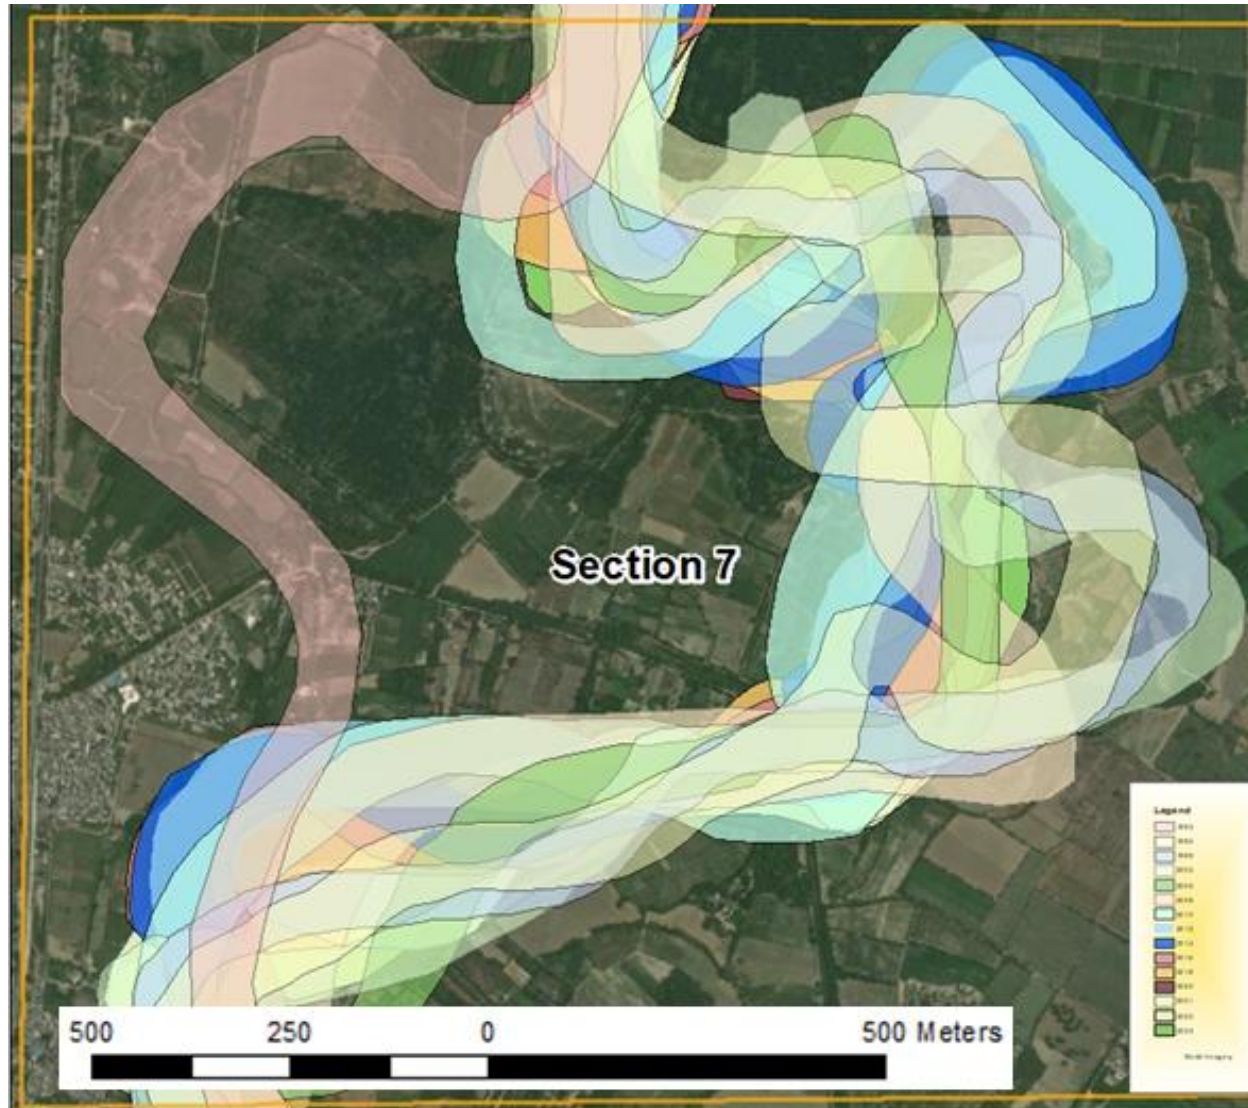
Figure 4.3: Year-wise shifting of river course River in section (reach) 1.

Figure 4.4: Year-wise shifting of river course River in section (reach) 2.

Figure 4.5: Year-wise shifting of river course River in section (reach) 3.

Figure 4.6: Year-wise shifting of river course River in section (reach) 4.

Figure 4.7: Year-wise shifting of river course River in section (reach) 5.

Figure 4.8: Year-wise shifting of river course River in section (reach) 6.

Figure 4.9: Year-wise shifting of river course River in section (reach) 7.

Figure 4.10: Year-wise shifting of river course River in section (reach) 8.

The river course in various years in each section is mapped and shifting is evaluated as shown in Figure 4.3 to Figure 4.10.

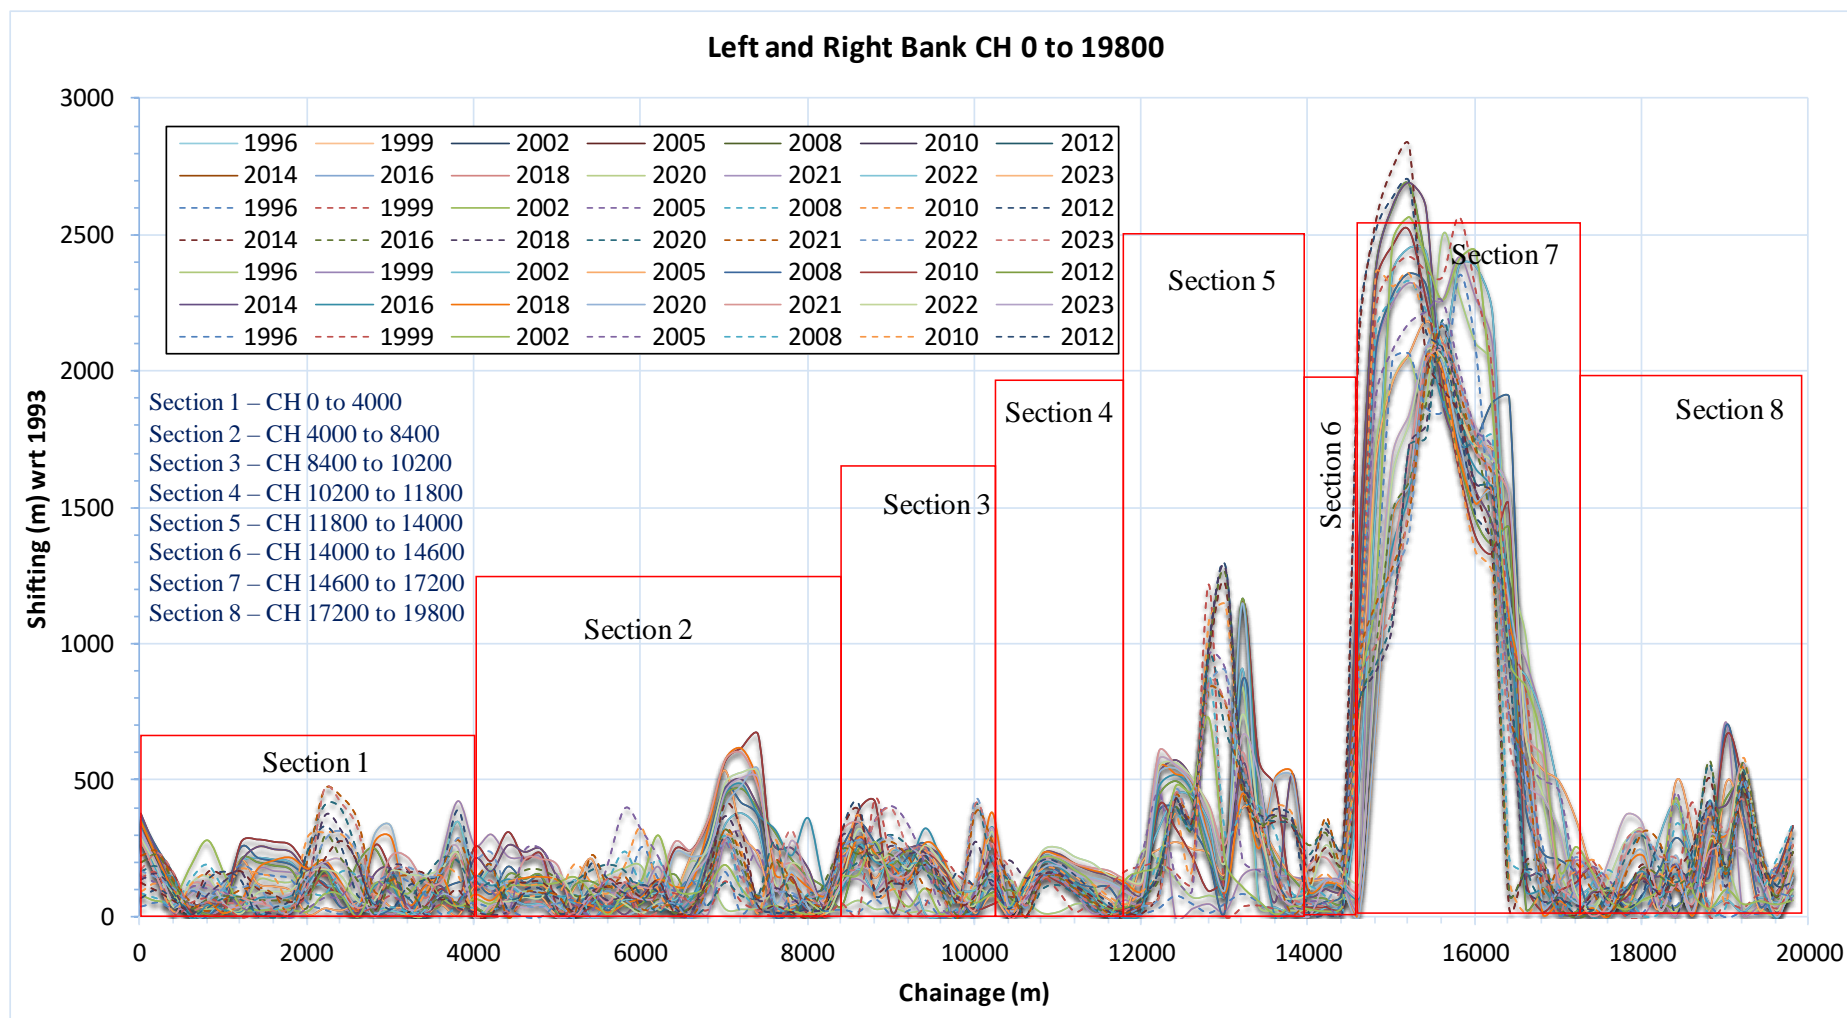
Figure 4.12: Year-wise bank line position in various years, the continuous line shows the left bank while the dashed line shows right bank.

Further to quantify the magnitude of shifting of left and right bank, a fictitious reference line (railway line running parallel to Bareilly- Nainital road) is identified. Along this reference line, points at regular interval of 200 m is digitized and the perpendicular distance of the river bank (left and right bank separately) is computed in GIS data base. The location of the reference points is shown in Figure 4.11. The distance of the bank line (left and right) extracted from satellite images of various years/ dates are measured. Considering the river bank line position extracted from 1993 satellite image, the change in the bank line in successive years are computed and analysed. Hence, the positions of the left and right bank line for each year with reference to 1993 bank line are computed and plotted as shown in Figure 4.12. In the figure the continuous line shows the positions of left bank while the dashed line is used to illustrate right bank positions. The colour of the left and right bank position is kept same for any specific year. For detailed visualization, the section-wise shifting of left bank and right bank are also plotted as given in Figure 4.13 to Figure 4.20. Further, the trend of maximum shifting in section 4 along left and right bank are also plotted and given in Figure 4.21. The figure shows that the minimum and maximum shifting of left bank is estimated as 140 m and 384 m, respectively for section 4. Similarly, for right bank, the minimum and maximum shifting is 170 m and 299 m, respectively.

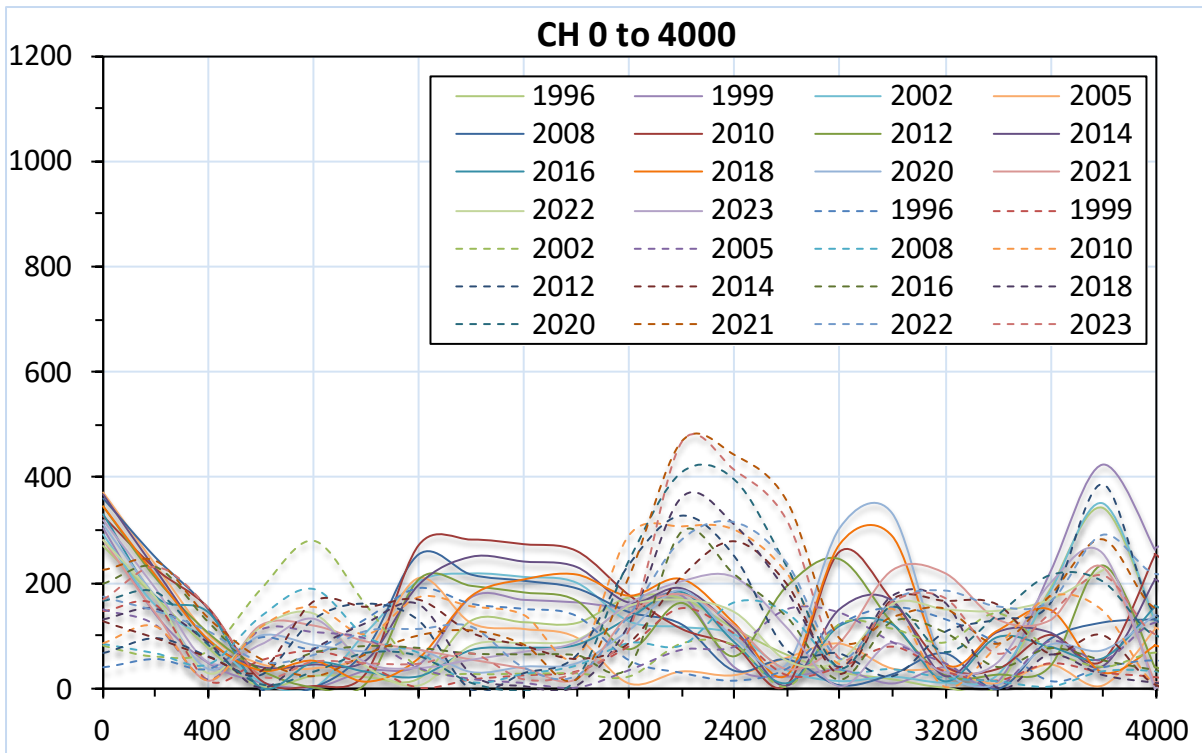
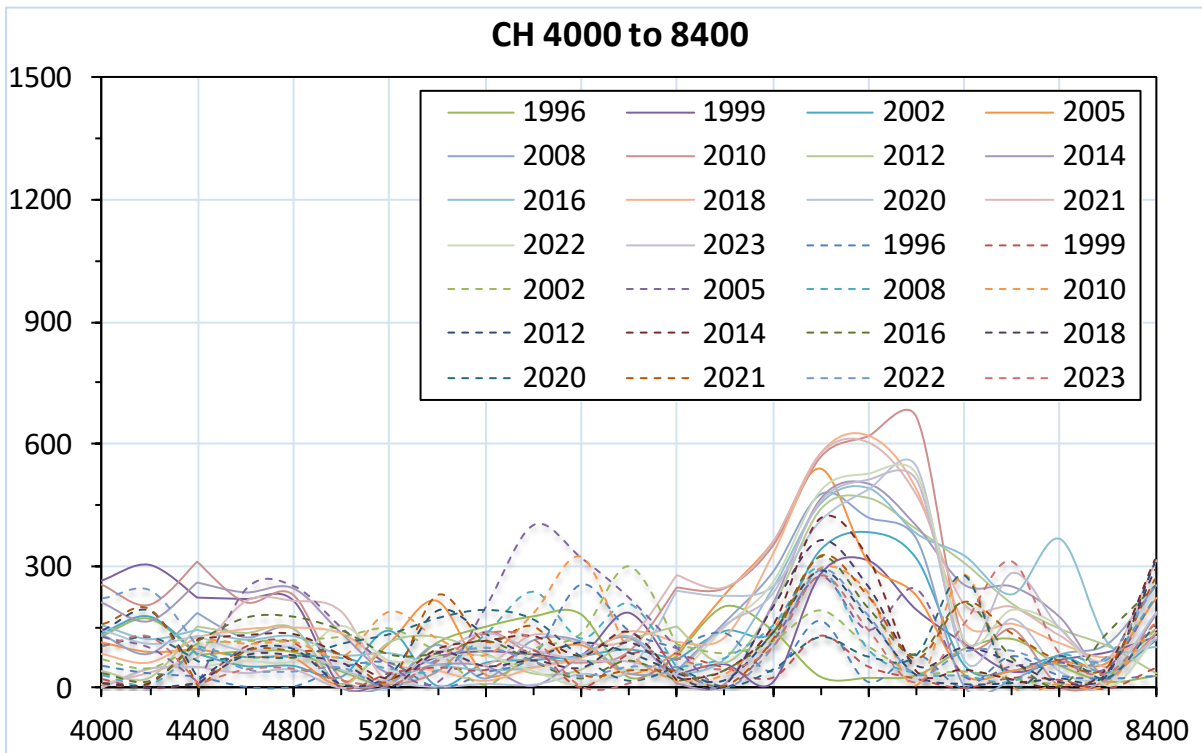
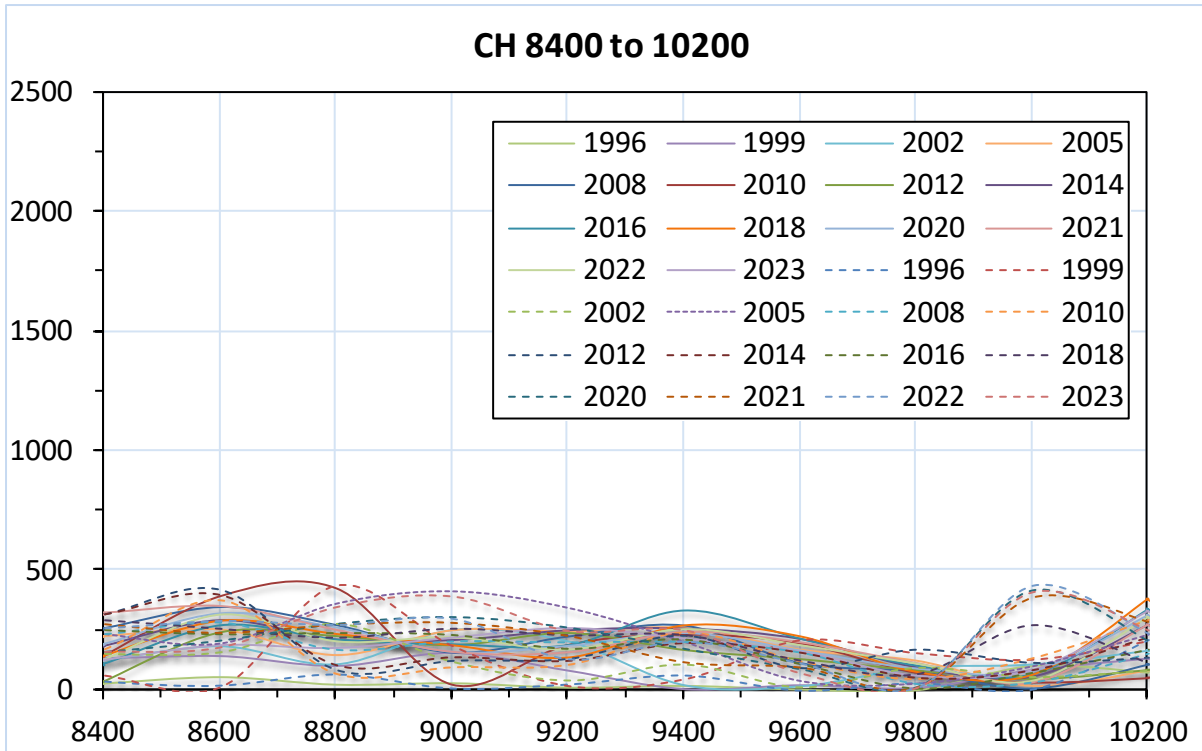
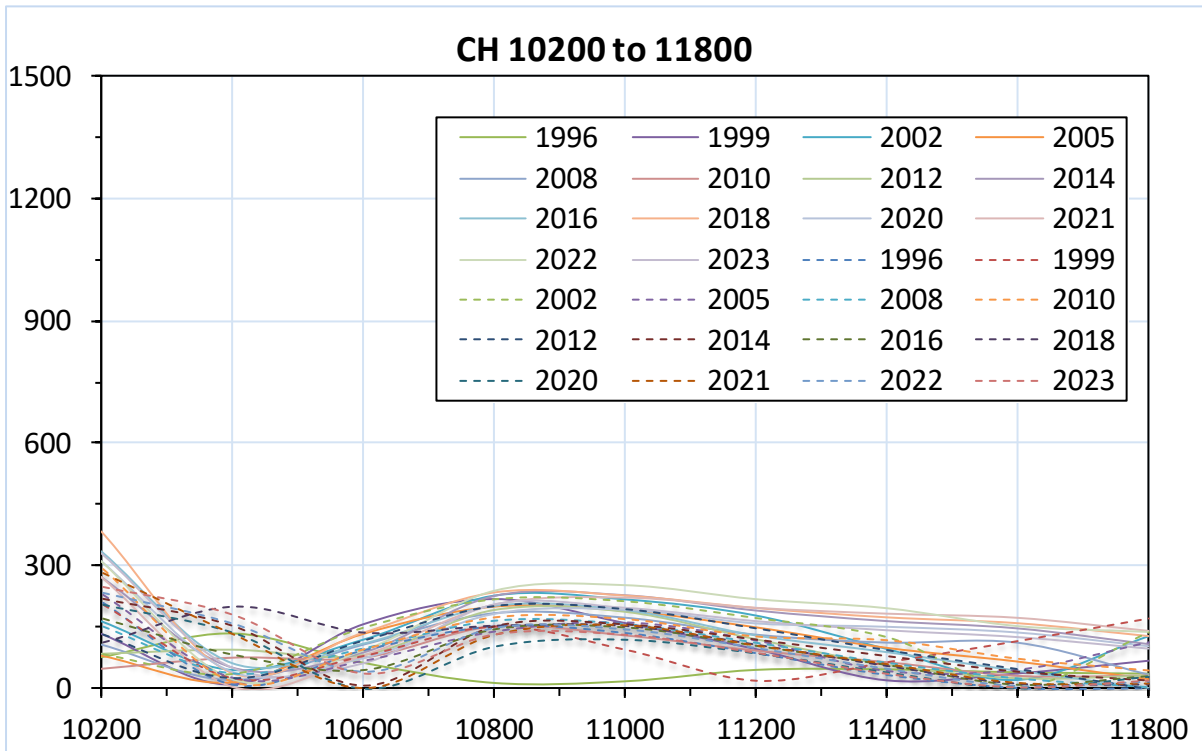
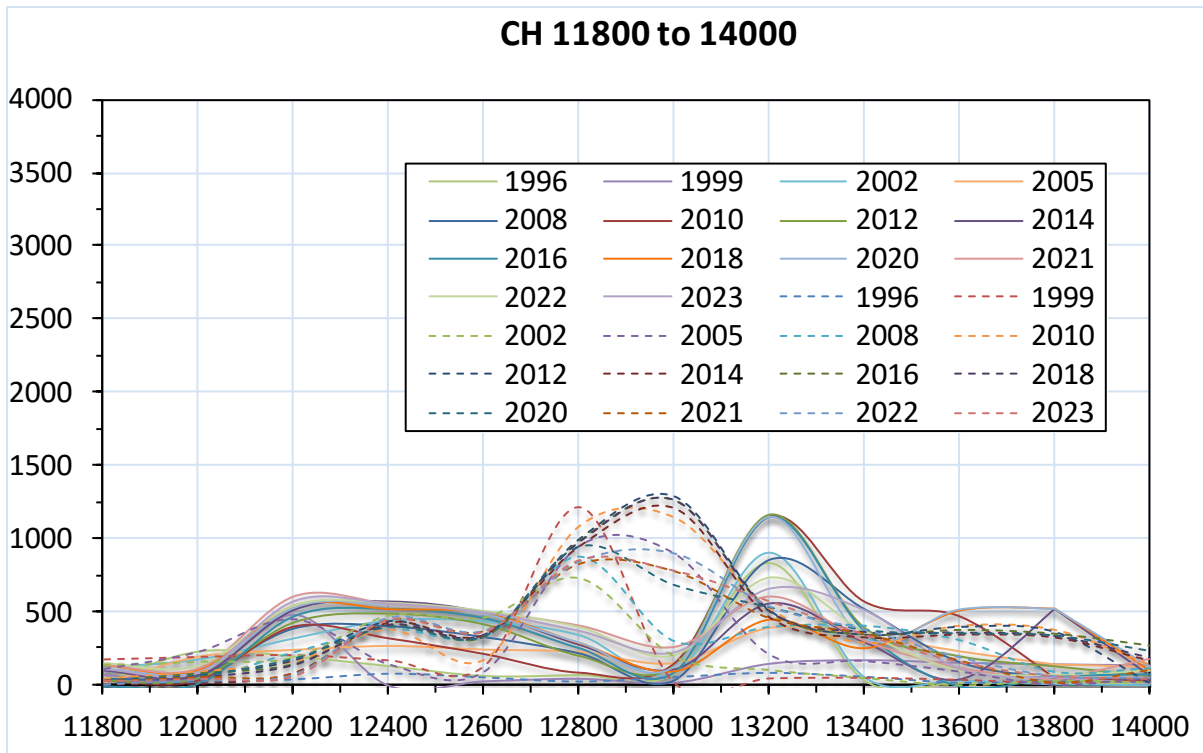
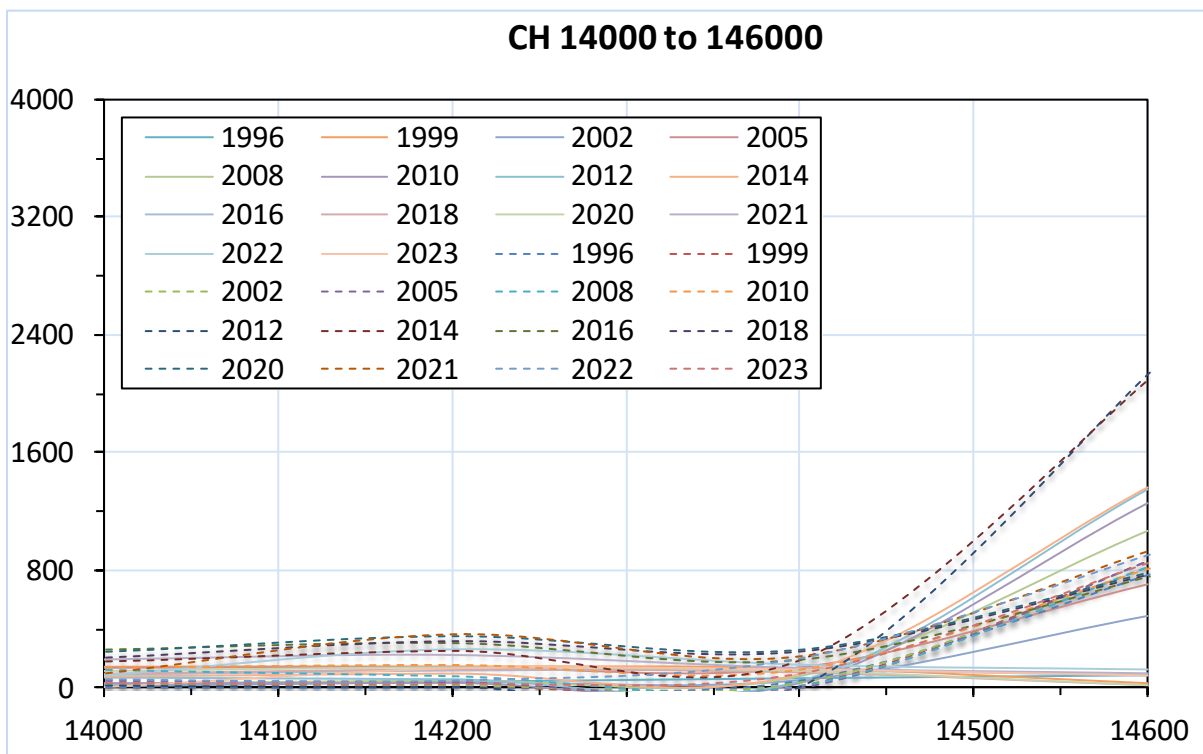
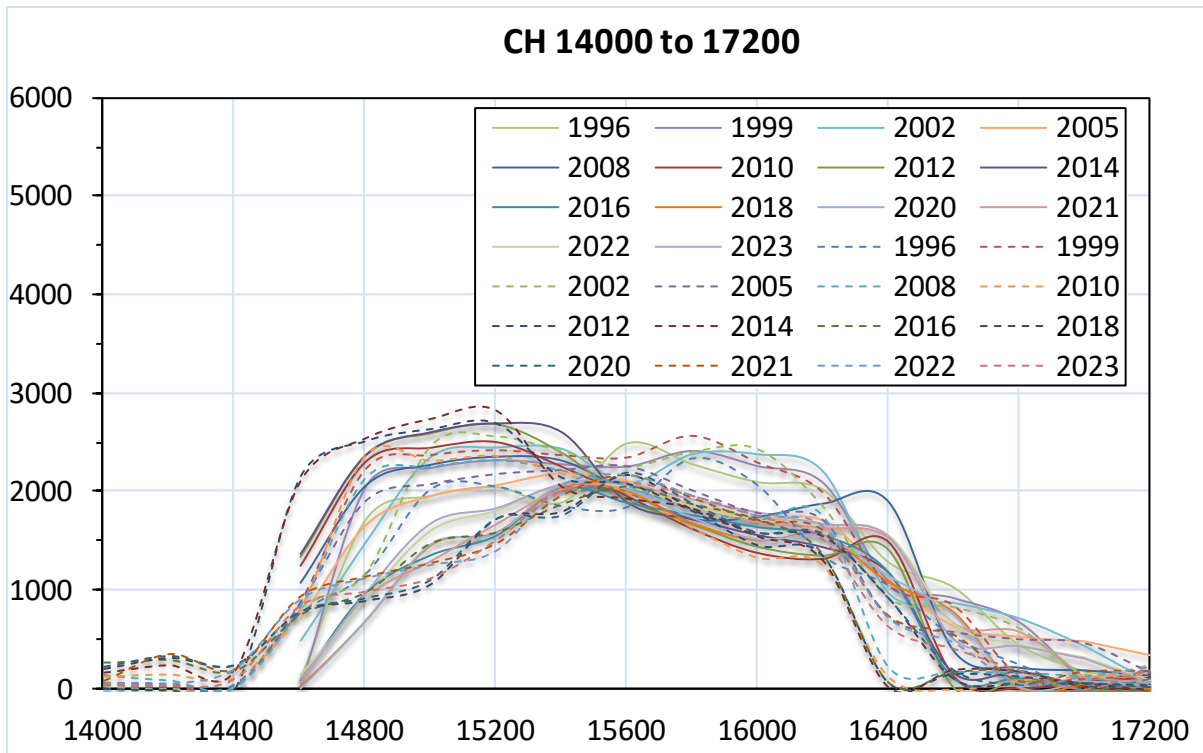
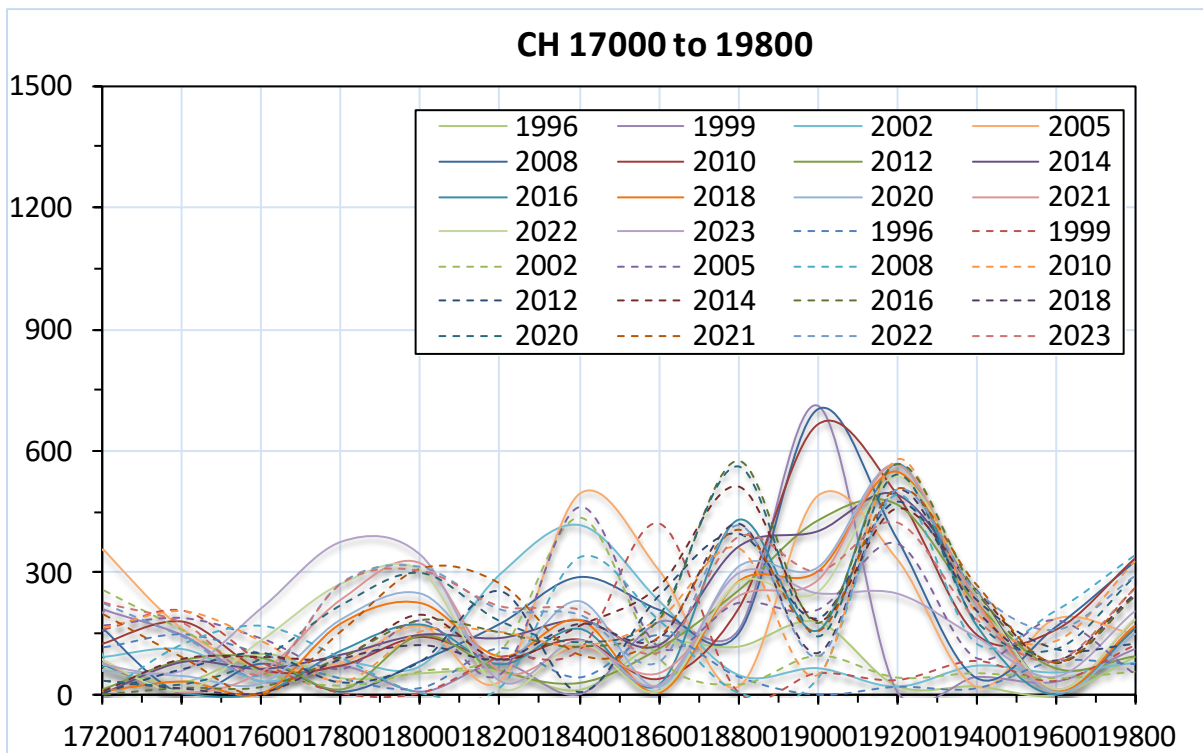
Figure 4.13: Year-wise bank line position for Section 1.

Figure 4.14: Year-wise bank line position for Section 2.

Figure 4.15: Year-wise bank line position for Section 3.

Figure 4.16: Year-wise bank line position for Section 4.

Figure 4.17: Year-wise bank line position for Section 5.

Figure 4.18: Year-wise bank line position for Section 6.

Figure 4.19: Year-wise bank line position for Section 7.

Figure 4.20: Year-wise bank line position for Section 8.

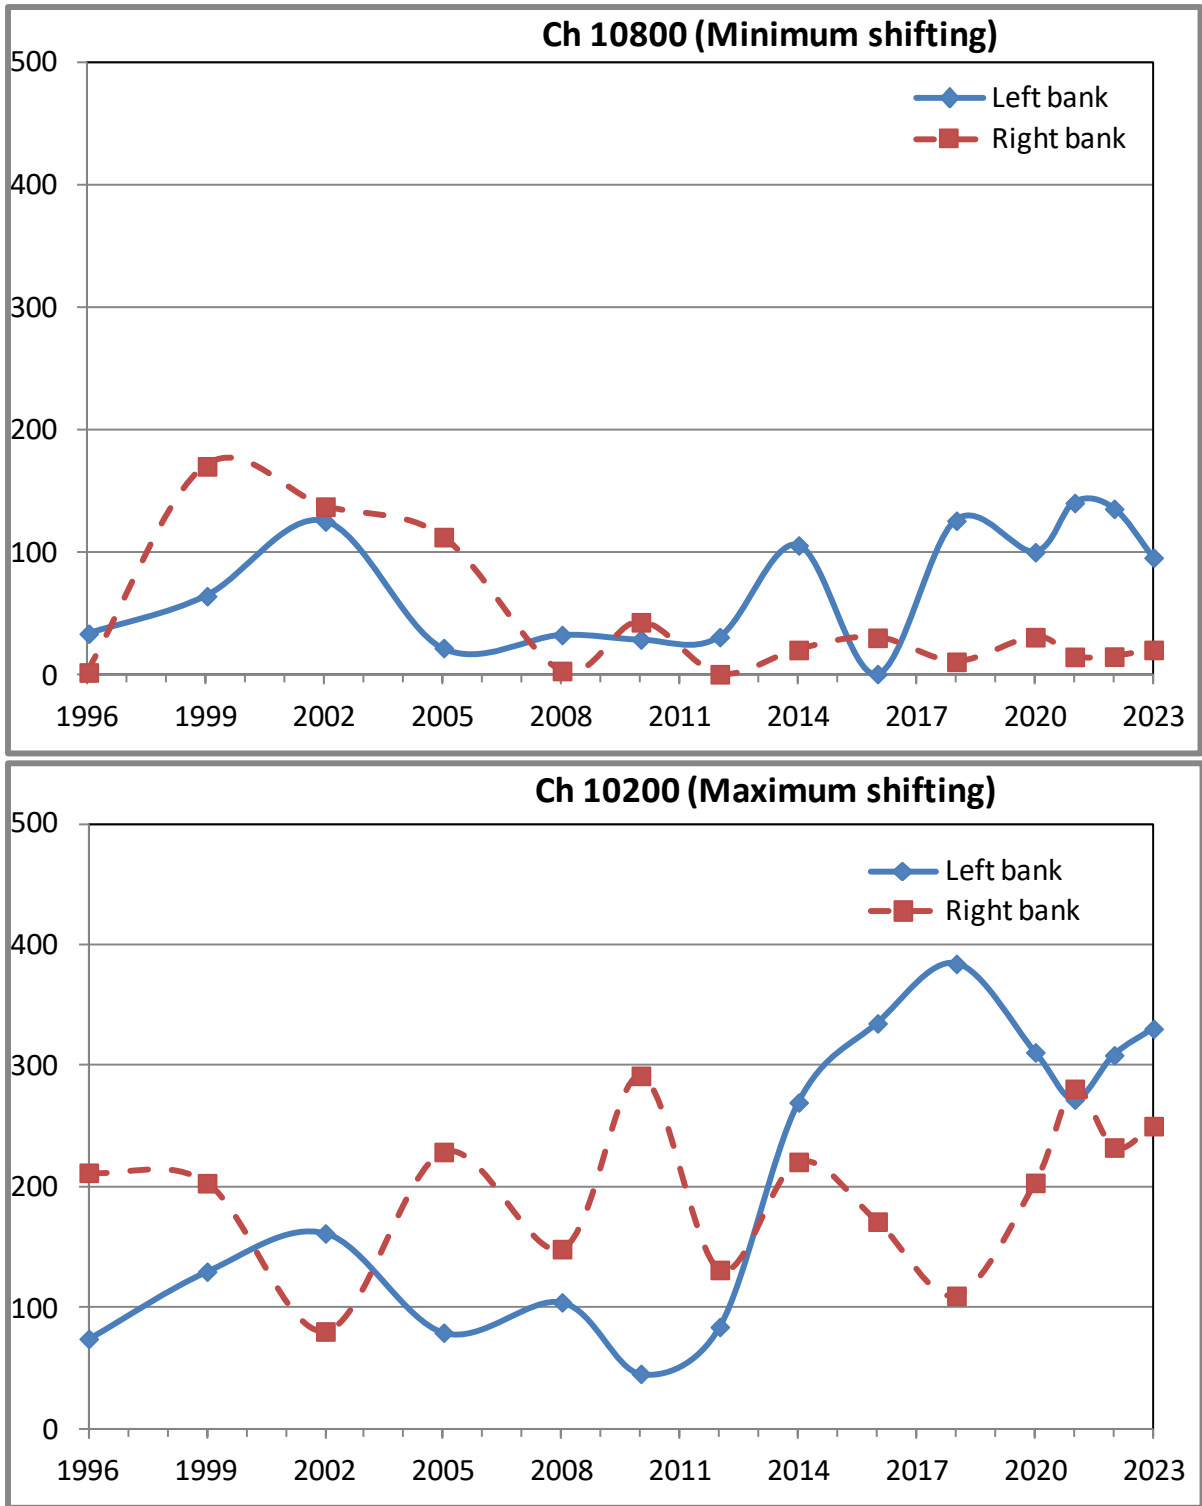
Figure 4.21: Trend of minimum and maximum river shifting in Section 4.

1. If the other site condition permits, the barrage should be located in stable river reach. Considering the most stable reach and vicinity of the exiting Kichha barrage, site Section 4 is identified as the most suitable reach. The maximum shifting of left and right bank of Kichha barrage is computed as 348 m and 299 m, respectively during the period of analysis of 1993 to 2023. Thus it is recommended to consider for the river training works at least in the river width covering this shift. However, this recommendation should further be evaluated in light of availability of land in this reach.
